14th Semiannual

ENVIRONMENTAL MONITORING REPORT (EMR)

Period: July-December, 2022

IRRIGATION MANAGEMENT IMPROVEMENT PROJECT (IMIP), BWDB

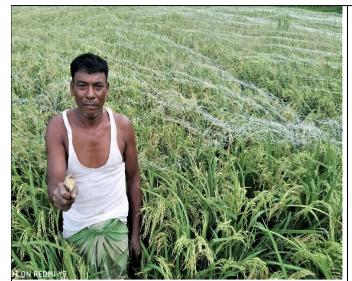
Figure 9: Prevention of Birds (One caught in hand) by using nets over the ripen crops demo plot at Feni Sadar.

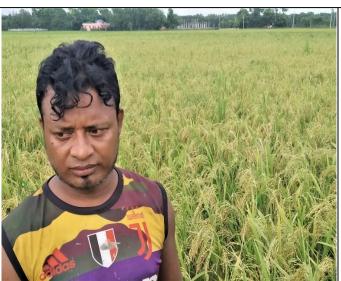
Figure 10: Bumper production of T. Aush Rice using Canal water polluted by poultry feces at Sonagazi, Feni.

C-IMO implemented some demonstration programs of vegetables (Figure: 12-14) and T. Aush rice (Figure: 9 -10) this year (2022) using the irrigation water polluted by poultry feces. No incidents of crop damage or loss of production or health hazards was noticed for using polluted water. Moreover, it was found that canal water polluted by poultry feces contains nutrients which promote the growth and flowering of vegetables which reduces the requirement/cost of organic fertilizer uses.

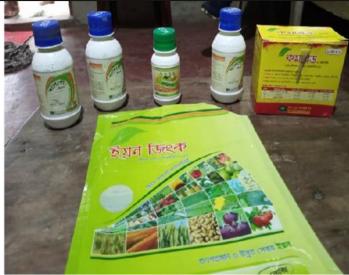
Figure 11: Pesticides and Fertilizers used in the demonstration plots

E2	Increased agrichemical s in surface and ground water systems	Excessive use of agrichemicals to increase crop yields and targeted crops may destroy biodiversity and aggravate public health.	Educating Farmers to use IPM method and reduce use of agrichemicals and ensure their proper management if necessary.	IMO will provide agricultural support	IMO/ BWDB	IMO budget	Farmers' have been warned on adverse impacts of excessive agrochemical use during farmers training programs and advised and also demonstrated Integrated Pest Management (IPM) which is considered more farmer and environment friendly method for pest control. The matter is kept under watch; necessary actions will be taken, when needed. During a visit to Kata Mobarakghona, Feni Sadar (FSD-06) on June-July, 2022 for monitoring demonstration of Transplanted Aush Rice (Figure-09) PMU Safeguard team recorded the adverse impacts of pesticide (Figure-11), prescribed by IMO-Extension & Training Specialist-ETS, use in the demonstration plot. The farmers used a pesticide "ALCO" (a contact poison) in their rice field successfully killed not only insects (stem borer) but also snakes, frogs, and fishes. He rescued dead body of two Shoal Fishes (large snake head) from his rice field after application of ALCO. The C-IMO has been advised to replace ALCO and monitor the impacts of the pesticides on the ecosystem (Figure: 11).

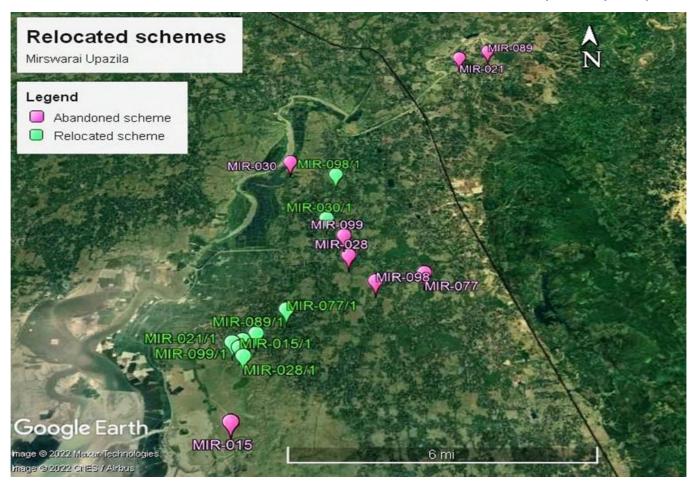
66. Location of old (Abandoned) and new (relocated) schemes in Mirswarai Upazila of Chittagong district are shown in Google Earth images with their possible impacts on natural environments one by one below (Figure: -24).

Figure 24 Relocation of schemes at Mirswarai Upazilal, Chattagram

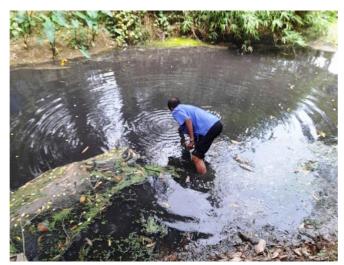
Figure 37: Water sample collection at Daliachara khal, Chhagolnaiya, Feni.

- 78. Some farmers and local people were raising complaints of high toxicity of the canal water polluted by domestic / industrial / poultry waste. In response to their complaints C-IMO takes initiative to test the physical and chemical parameters of surface water (polluted Irrigation Canal water) from 15 points. The water samples were collected by C-IMO field staff (Figure: 37-40) and tested in BUET Laboratories during the last 6 June, 2022 (Table-17). Details are stated in the test scripts (Annex-5.7).
- 79. The C-IMO informed the PMU safeguard team that the surface water samples were tested only for investing the toxicity of polluted canal water and motivating the concerned defendants of polluted canal area not for the purpose of revising/updating the environmental baseline of IEE report.

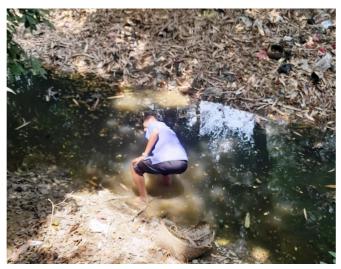
Figure 39: Water sample collection at Churamoni khal, Mirsharai, Chitagram

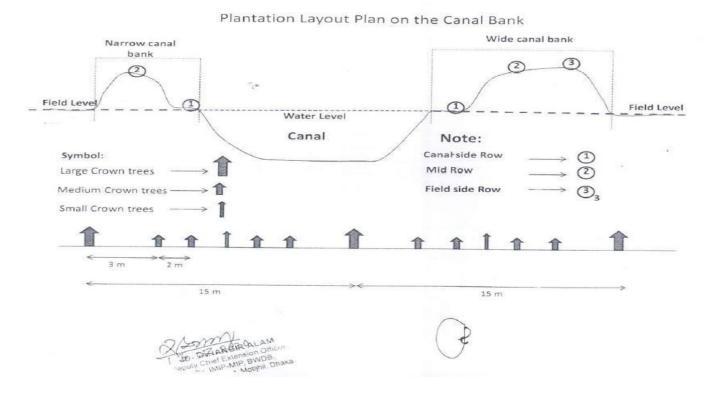
Spacing from plant to plant along the row of the canal bank

l. No.	Row position	Species name	No of Saplings to be planted	Spacing from nearby plant	Spacing from same plant
1		Raintree/Gamar,	400	3 m	15m
2		Shilkoroi	100	3 m	15m
3	Canal Side Row	Chalta	50	3 m	50m
4		Gab	50	3 m	50m
5		Jambura	50	3 m	50m
7		Jam .**	100	2 m	50m
8		Jalpai/Tentul	50	2m	50m
9	Mid Row	Arjun	50	2m	50m
10		Amloki	50	2m	50m
1.1		Nim	100	2m	25m
12	Field side RoW	Akashmoni	1000	2m	2m
		Mangium	1000	2m	2m

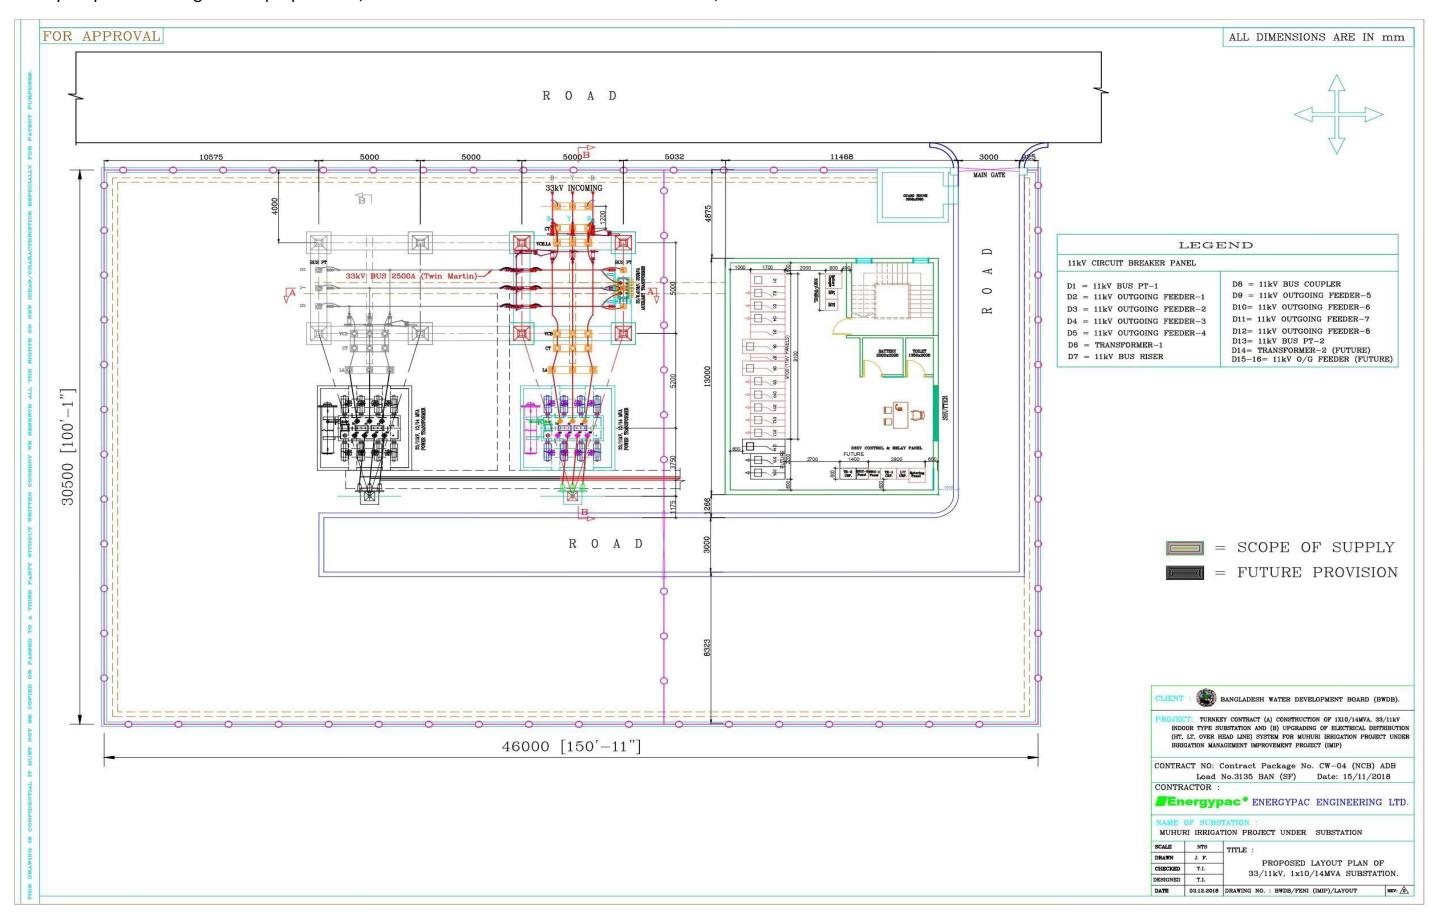
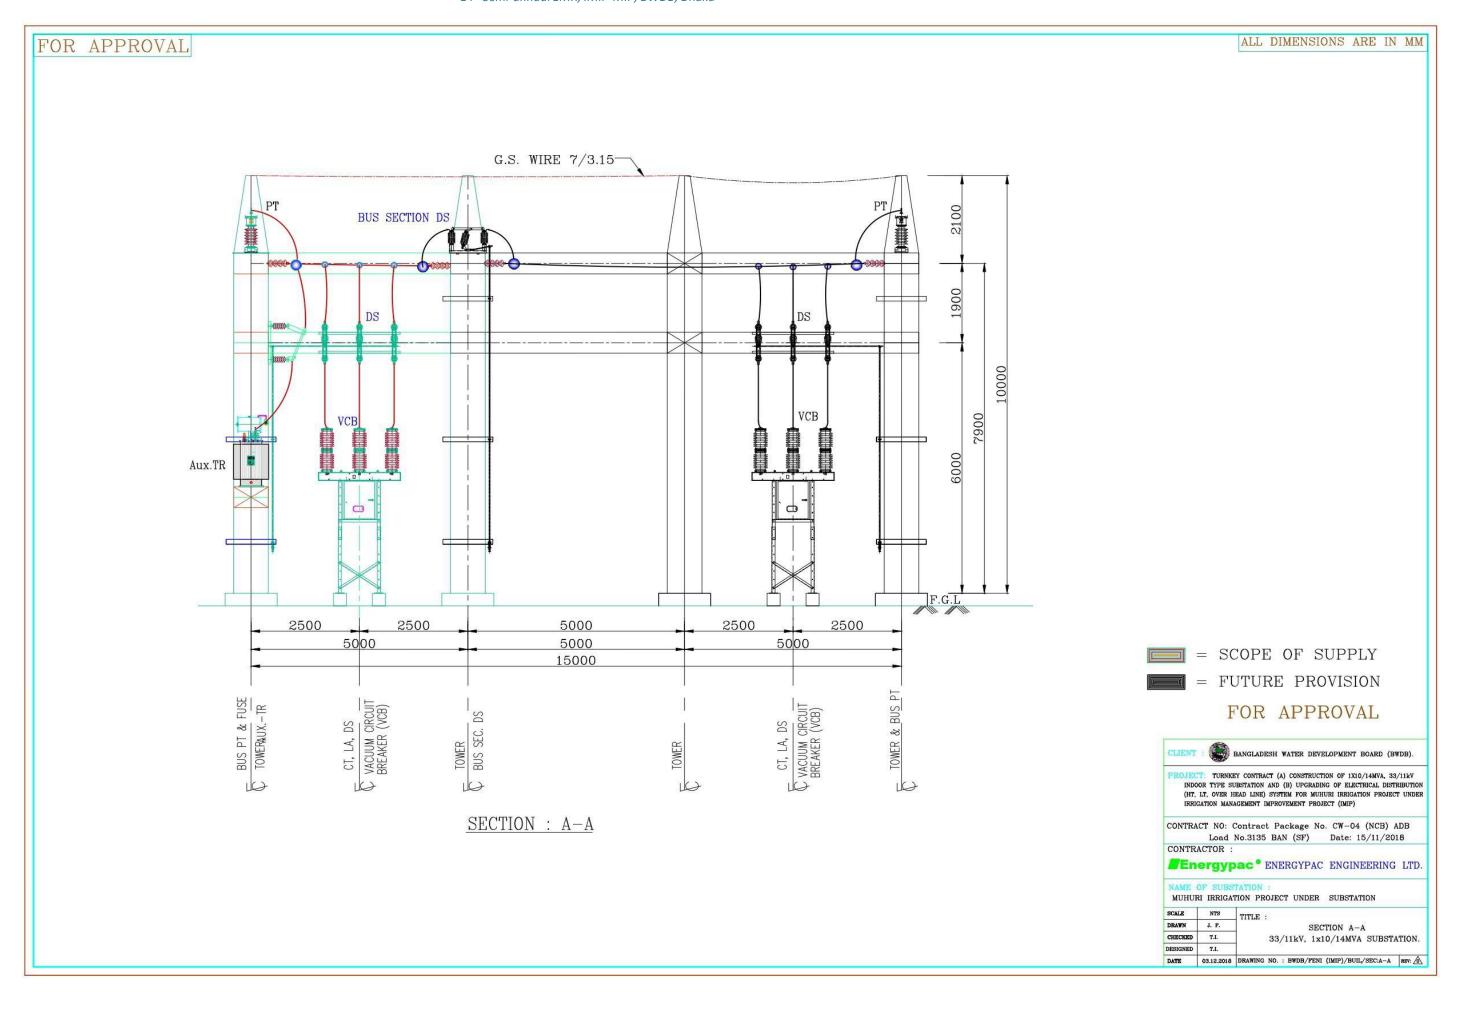
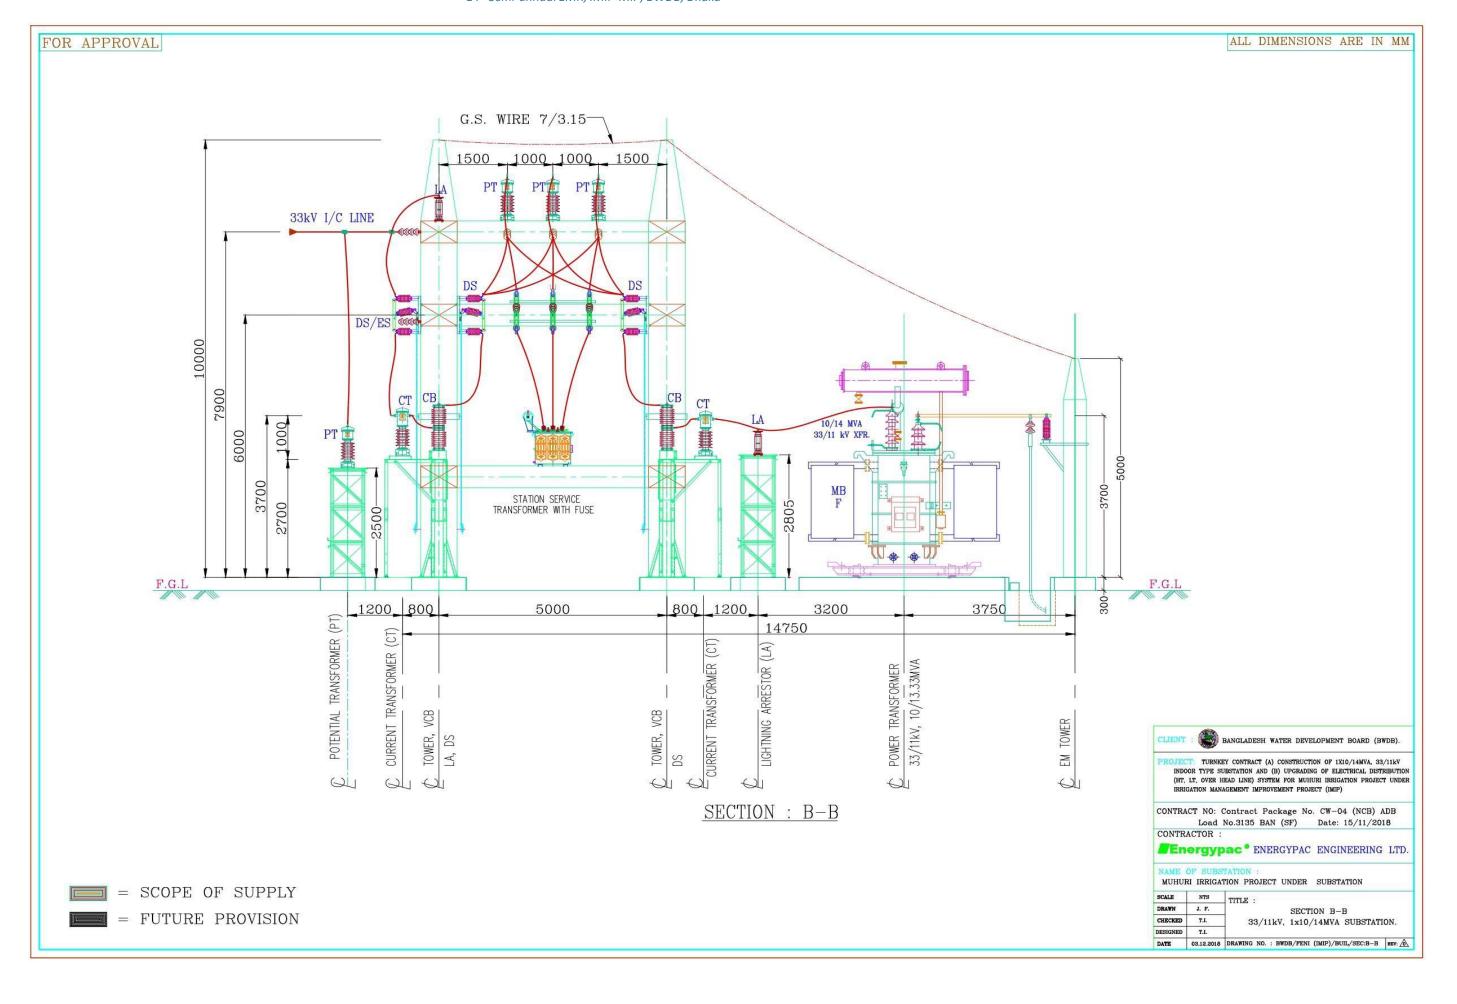
5.13 DESIGN AND LAYOUT PLAN OF THE PROPOSED ELECTRICAL SUBSTATION

The layout plan and design of the proposed 33/11 KV Electrical substation for MIP under IMIP, BWDB is attached below
